Chapter 2

THE ACCOUNT OF WORLD TRADE CENTER 1

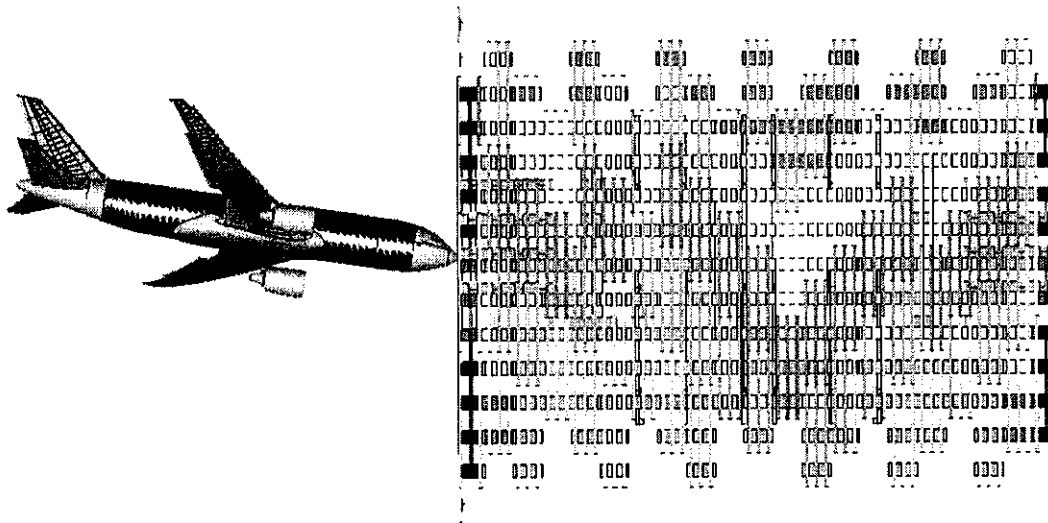
At 8:46:30 a.m. EDT, five hijackers flew American Airlines Flight 11 (AA 11) with 11 crew and 76 passengers into the north face of WTC 1 (Figure 2-1).

Figure 2-1. Simulated impact of American Airlines Flight 11 with WTC 1.
